Where Cities Meet Wildlands

## Watershed Rehabilitation and echniques

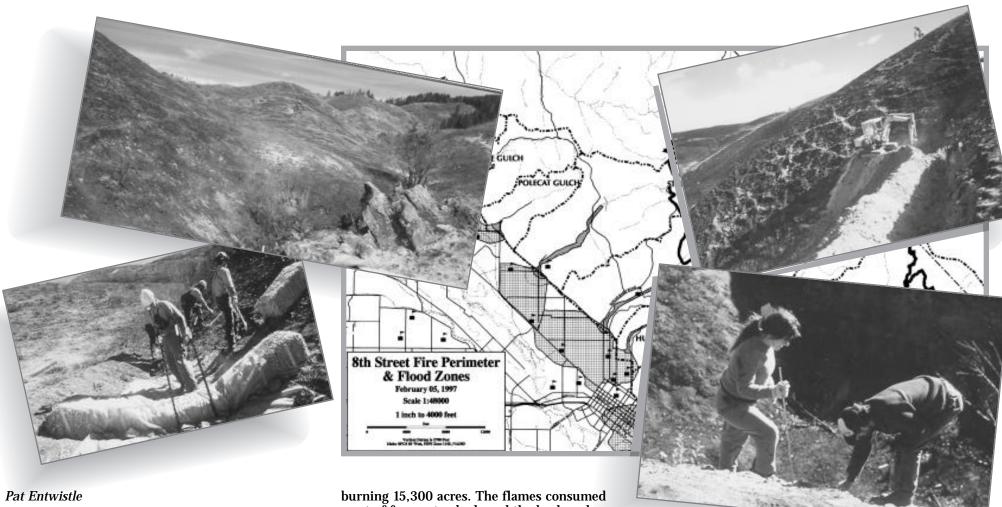
Clockwise from top left, straw bail check dams were constructed in drainages to slow runoff and store sediment. The fire destroyed bridges and other improvements to the Hulls Gulch Interpretive Trail system. Mini excavators were used to dig trenches to help stop erosion at the

upper elevations. Volunteers donated more than 2,000 hours performing such tedious jobs as hand-planting bitterbush seed. Remote Automatic Weather Stations provided by the National Interagency Fire Center transmit weather information to the National Weather Service to help in forecasting flood danger.

**Mechanical Contour Trenches**: At the upper levels, about 1,000 acres were treated with about 40 miles of trenches constructed by miniexcavators. Trenches are 2-3 feet wide and 2-3 feet deep. They are spaced vertically about 75-120 feet apart on 40 to 65 percent slopes. As runoff and erosion occur, sediment will collect

Straw-Bale Check Dams: Straw bales were used to build 2,230 check dams across the smaller stream channels, higher in the stream systems where flood waters potentially would not yet have had a chance to build significant force. A series of straw bales are laid end-to-end, wrapped in chicken wire or photodegradable mesh, and positioned across the channel in a shallow trench. An erosion cloth is draped across the bales, which allows water to flow through while retaining the soil. These dams will help trap and temporarily store runoff of water and sediments, prevent down-cutting of the channel, and reduce peak flows by routing water through several small basins.
